# *Operation* **UPSHOT-KNOTHOLE** NEVADA PROVING GROUNDS

EFFECTS OF AN ATOMIC EXPLOSION ON TWO TYPICAL  
TWO-STORY-AND-BASEMENT WOOD-FRAME HOUSES

FEDERAL CIVIL DEFENSE ADMINISTRATION  
WASHINGTON D.C.

Report to the Test Director

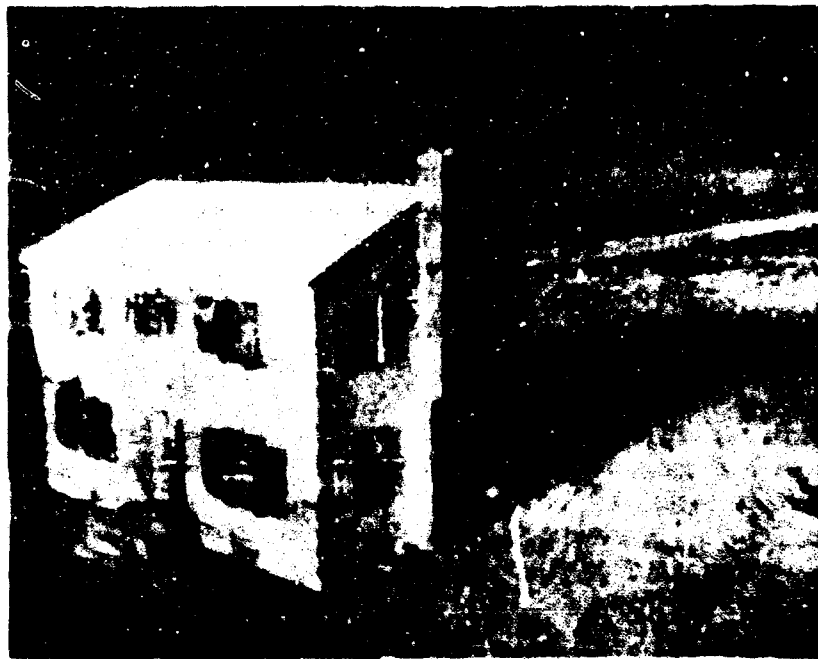
Fig. 1.2—House at 3500 ft,  $\frac{5}{16}$  sec after detonation. The charring deepens around the windows and doors; the wood base of the floodlight pole (lower right) is smoking.

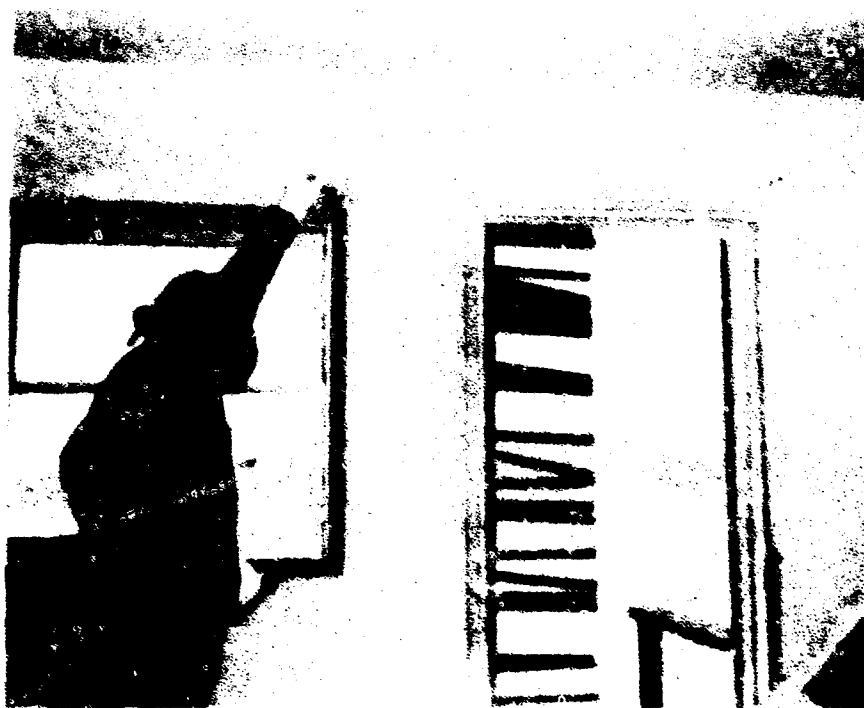
The kitchen in the rear of the house was protected somewhat by the partition wall between it and the dining room, yet furniture was thrown about, and the door to the dining room was broken and portions embedded in the plaster of the rear wall, as shown in Fig. 2.24. Figure 2.25 shows part of the kitchen-celling damage. The kitchen wall on the side of the house, between the door and window, bulged inward slightly, causing plaster cracks, as indicated in Fig. 2.26. The studs in this part of the wall may have been broken.

Fig. 2.26—Kitchen entrance after the blast showing plaster cracks.

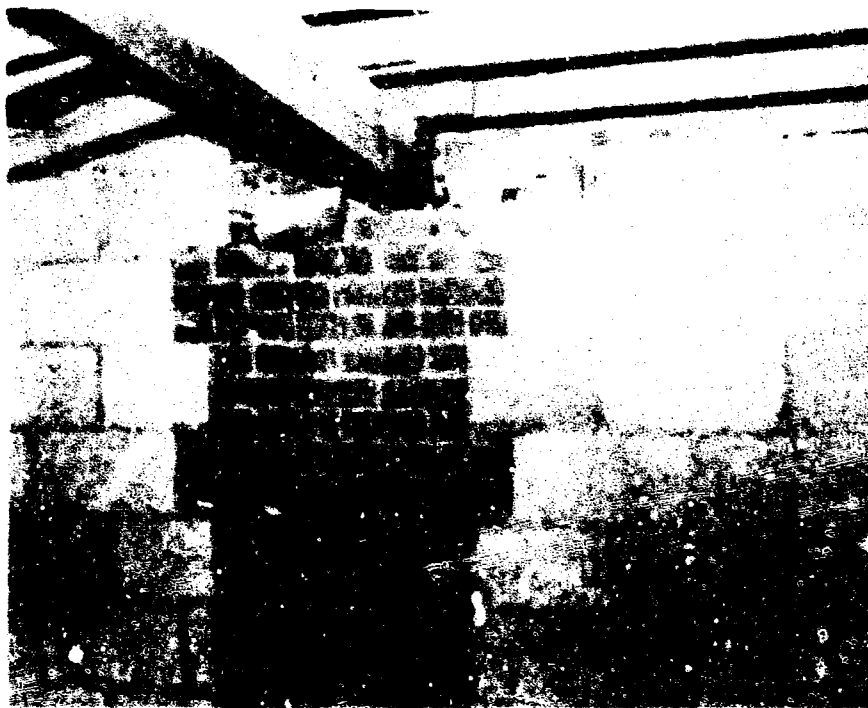
Fig. 2.47—Rear wall punctured by a wood girder.

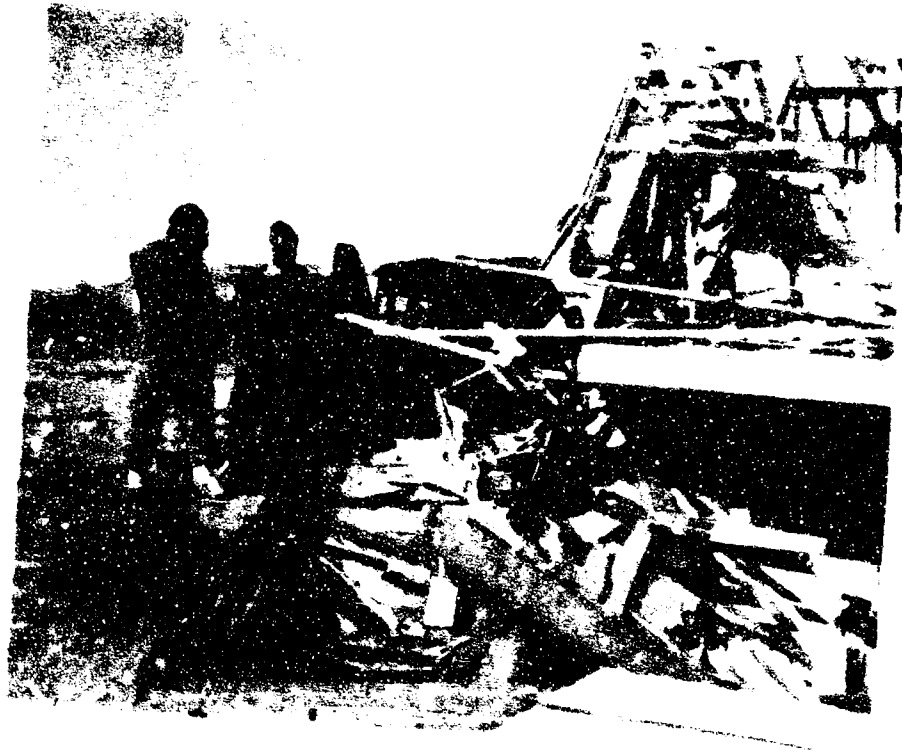
Fig. 2.55—Rotation and movement of the second story at front.

The second story did not drop vertically on the first floor but moved with a clockwise rotation in relation to the front basement wall of the house. The right front corner of the second floor settled 5 ft 8 in. from the front and 8 ft 3 in. from the right-side basement wall, while the left front corner of the second floor was 12 ft from the front basement wall and overhung the left-side basement wall by 10 ft 2 in. The motion appeared to be a rotation and a movement toward the left rear corner of the foundation wall. This is shown in Fig. 2.55.

The box-sill construction used at the top of the block foundation wall failed. Generally, the 2- by 8-in. plate, which was bolted to the block wall, remained in place. In the front of the house, the 2- by 8-in. closure or header split at the top horizontally, with the top portion moving with the first floor and the lower portion remaining with the plate, as shown in Fig. 2.55. At the sides of the house, where the closure was nailed into the ends of the floor joists, the nails bent, allowing the joists to slide to the rear of the house with the floor and separating the closure from the plate. This is also illustrated in Fig. 2.55.

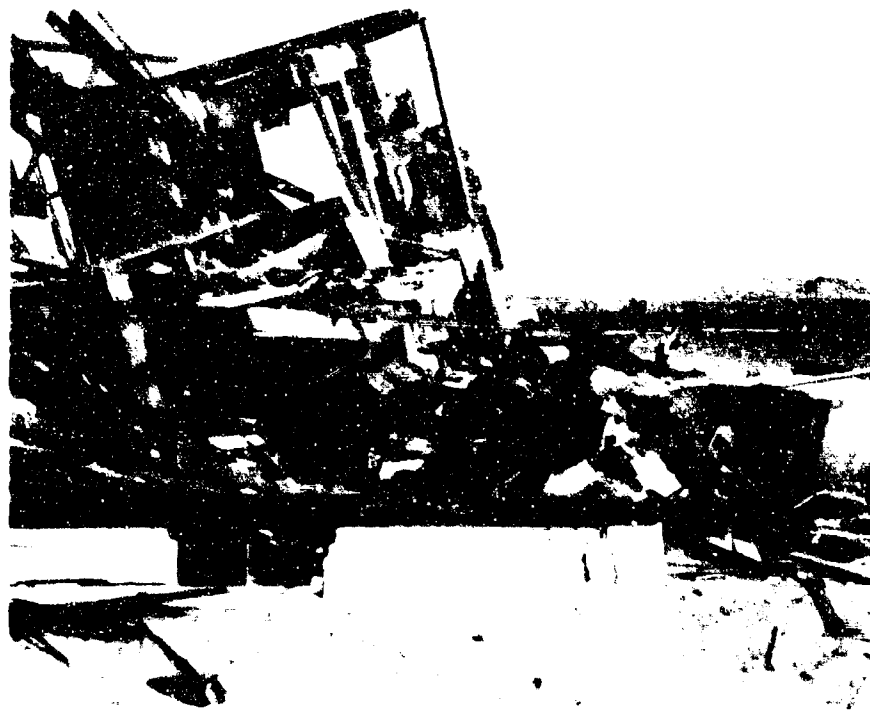
Fig. 2.57—Front foundation wall above grade after the blast.

The foundation wall above grade suffered little damage on the front and sides but was damaged at the rear by the movement of the first-floor system. However, the front foundation wall (Fig. 2.57) was cracked through vertically from sill to basement floor at each end, about 1 ft from the corner, and was moved in at the top about 1 in., hinging at the basement floor level. The hinged wall showed no bowing or cracking, however. Lateral earth pressure due to the pressure on the ground in front of the house was the most probable cause of this effect.
